INDOOR AIR QUALITY ASSESSMENT

**Templeton Town Hall
9 Main Street
Templeton, Massachusetts**

Prepared by:
Massachusetts Department of Public Health
Bureau of Environmental Health Assessment
Emergency Response/Indoor Air Quality Program
December 2002

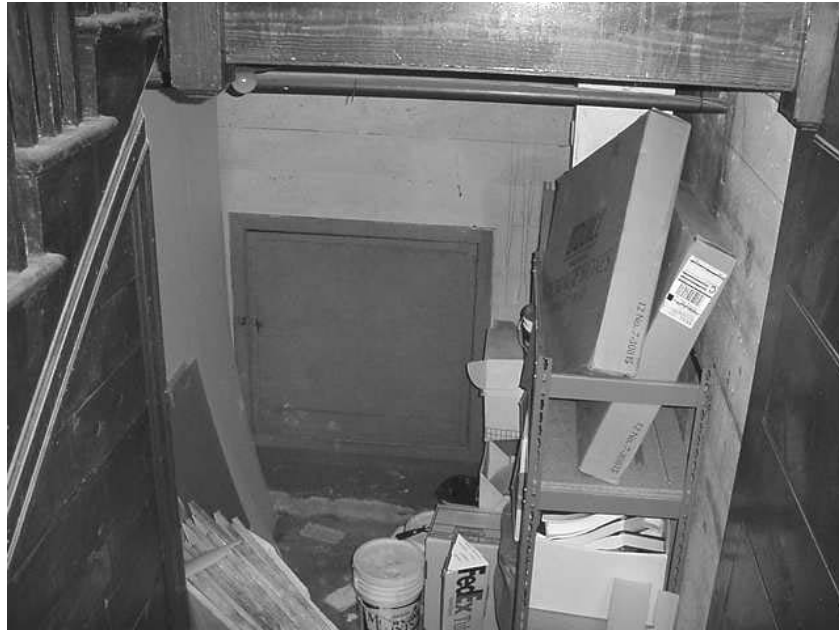
Picture 1

Storage Of Materials In Basement/Base Of Stairwell

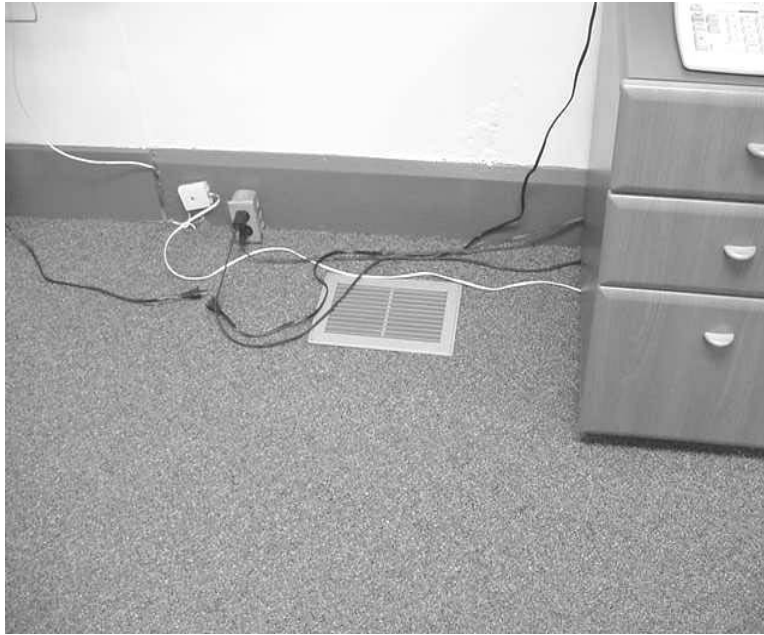
Picture 2

Fresh air is supplied by fresh air diffusers (see Picture 2) that are connected by ductwork to several air handling units (AHUs) located in the dirt floor portion of the basement (see Picture 3). Each AHU is mounted in the ceiling of the basement. Located on the north and south foundation walls are metal hoods that appear to be the fresh air intakes for each AHU (see Picture 4). Fresh air intakes are connected to each AHU by ductwork.

Floor Installed Fresh Air Diffuser

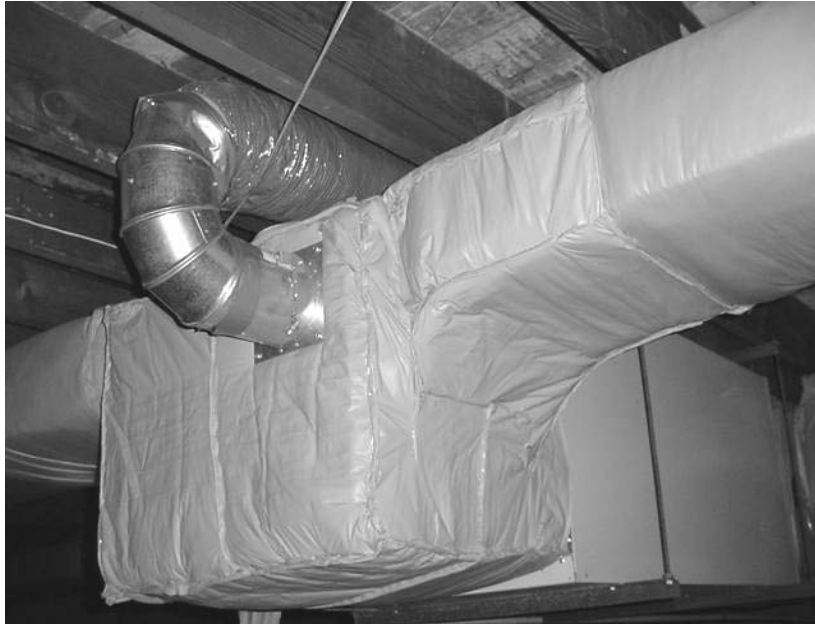
Picture 3

AHU Over Basement Dirt Floor

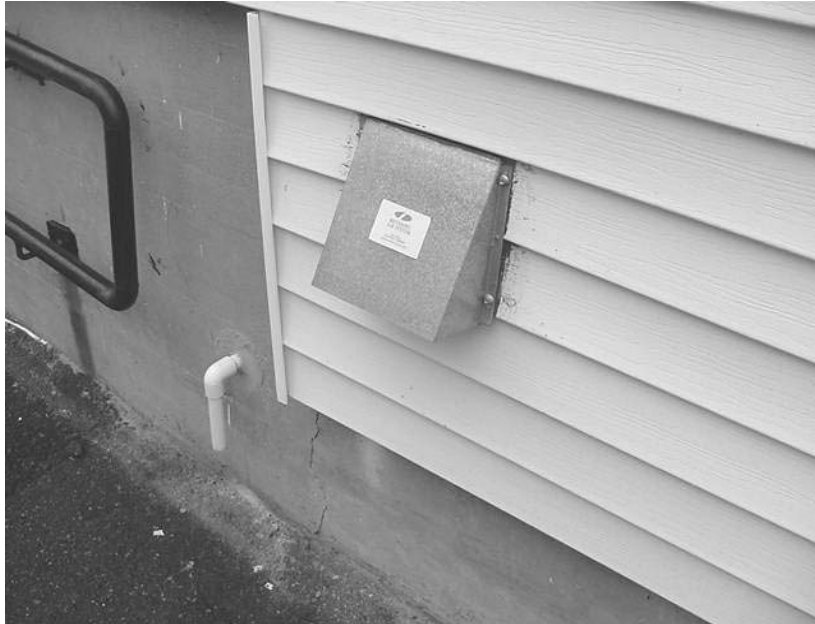
Picture 4

Fresh Air Intake For AHUs

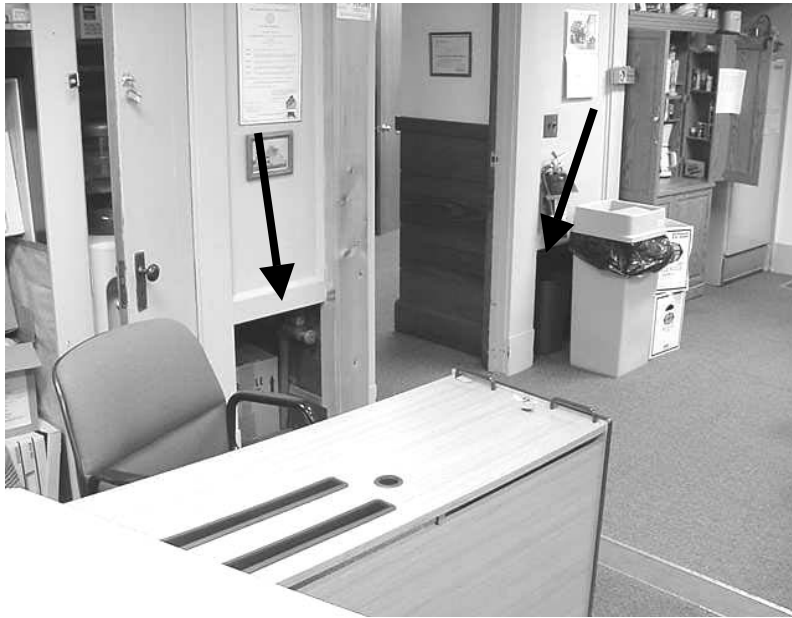
Picture 5

Exhaust ventilation was originally provided by an ungrated hole located at floor level (see Picture 5). A louver located inside the duct controls airflow. A heating element (see Picture 6) is located above the louver that creates airflow via rising heat called “the stack effect”. The vent that originally exhausted air from the building was sealed (see Picture 7). The abandonment of the exhaust vents essentially prevents air

Exhaust Vent

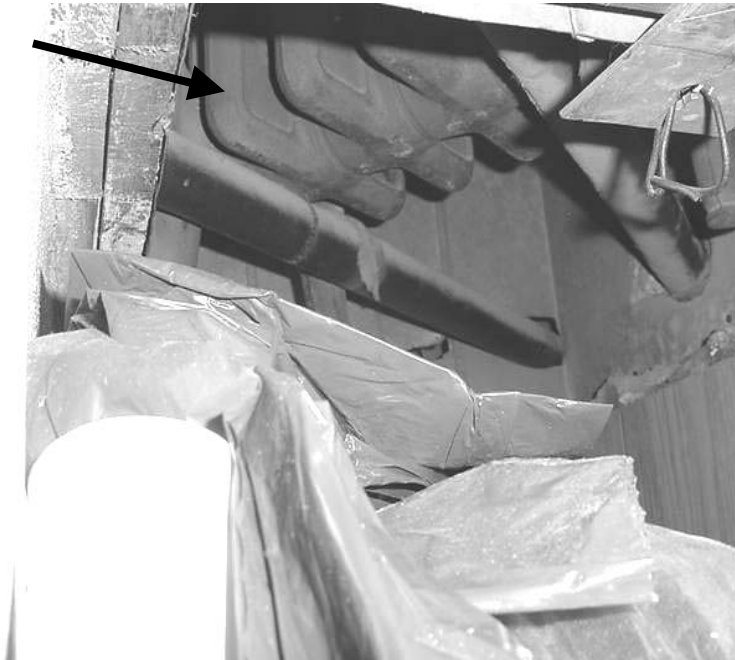
Picture 6

Heating Element Above Louver In Exhaust Vent

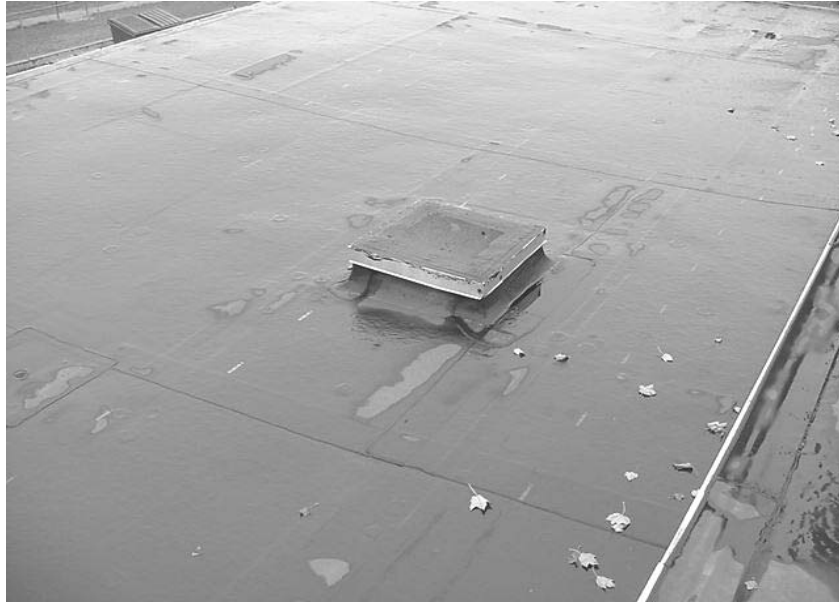
Picture 7

from exhausting from the building. It appears that the building does not have a functioning exhaust ventilation system. Without exhaust ventilation, normally occurring environmental pollutants can build up and lead to air quality/comfort complaints.

Sealed Original Exhaust Vent

1. Consideration should be given to repairing the original exhaust ventilation system. Consult a ventilation engineer to determine whether existing ductwork can be restored.
2. Examine the feasibility of increasing the size of the roof drain.

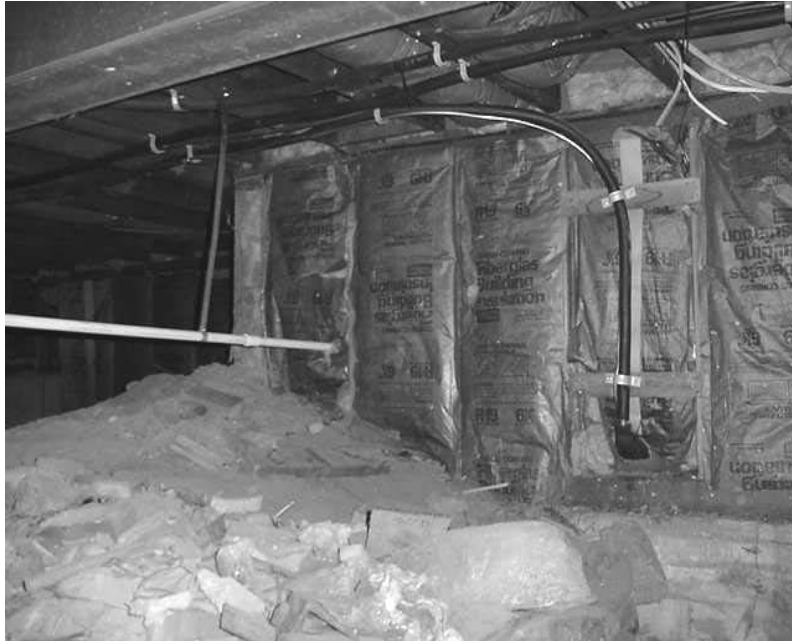
Picture 8

2. If water penetrates through the foundation, moisture may accumulate in the basement. In an effort to improve energy efficiency, fiberglass insulation was affixed to the foundation walls. It appears the purpose of the insulation is to prevent air penetration and heat loss through the foundation (see Picture 8). The paper on the insulation can support mold growth if wetted. The installation of insulation also prevents natural ventilation of the crawlspace that can lead to the accumulation of water vapor. Water exists in the basement, as evidenced by a sump pump in the basement (see Picture 8A).

Insulation On Foundation Walls

9. Examine the fiberglass insulation along foundation exterior for moisture or mold colonization. If mold growth is present, replace the fiberglass. Please refer to recommendations #1 and 2 prior to acting on this recommendation.

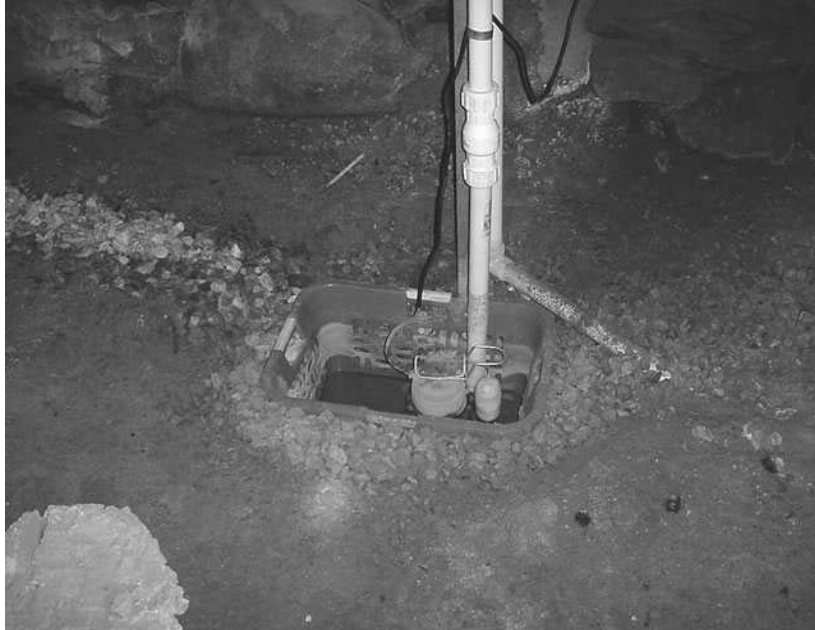
Picture 8A

Sump Pump In Basement

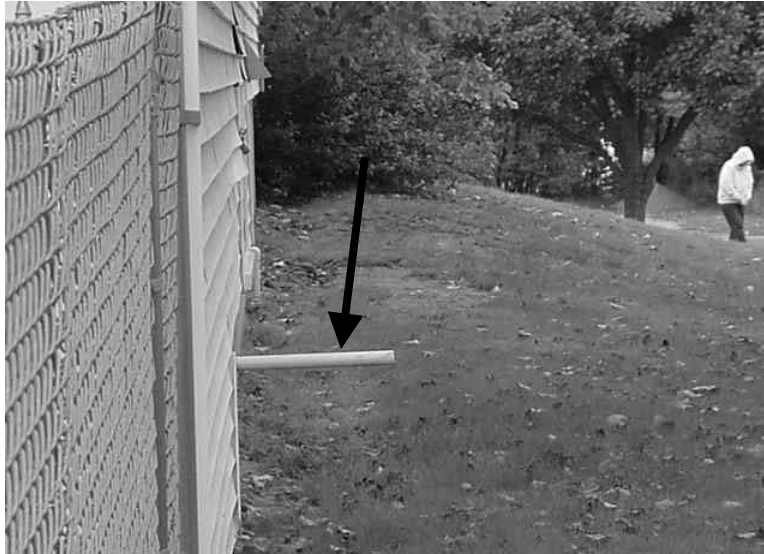
Picture 9

3. The condensation drains for the building empty near the foundation (see Picture 9). This configuration creates water pooling along the south foundation wall, which may then penetrate through the wall into the basement.

4. Water pooling on the south wall is exacerbated due to landscaping. The ground at the foundation is flat and covered with grass. Rainwater runoff from the south exterior wall can drip onto the grass, enhancing the pooling effect.

Condensation Drains On South Wall Of TTH, Note Pitch Of Ground Toward Foundation

- a) Move foliage to no less than five feet from the foundation.
 - b) Improve the grading of the ground away from the foundation at a rate of 6 inches per every 10 feet (Lstiburek, J. & Brennan, T.; 2001).

- c) Install a water impermeable layer on ground surface (clay cap) to prevent water saturation of ground near foundation (Lstiburek, J. & Brennan, T.; 2001).

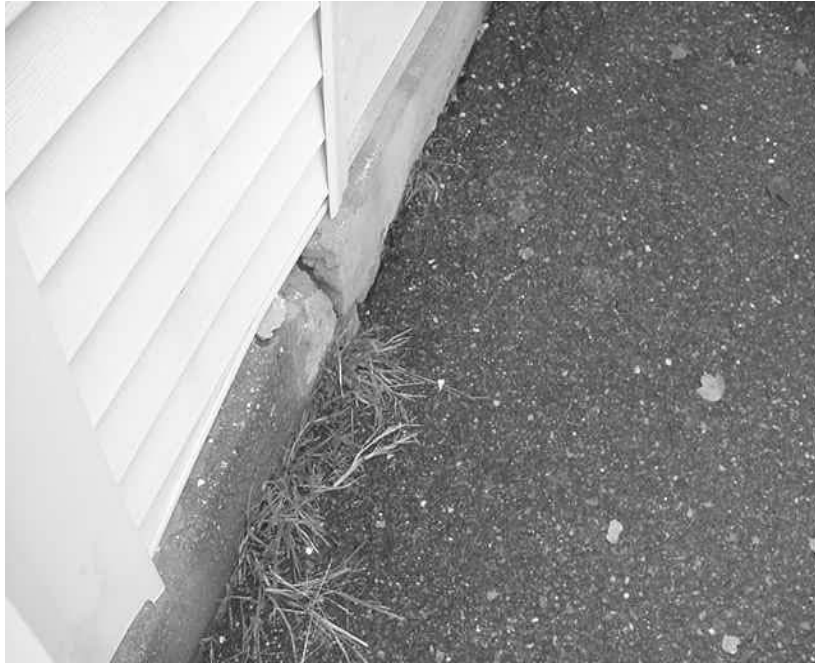
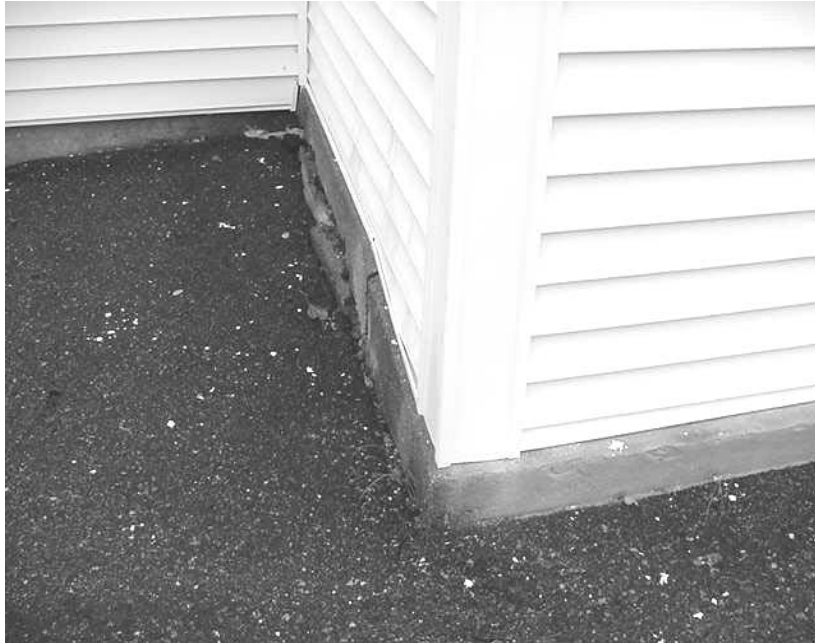
5. Opportunities for water penetration through the building envelope exist along the exterior wall/tarmac junction along the north and west walls of the TTH. Large spaces and damaged brick/mortar were also observed in the exterior wall/tarmac junction at the rear of the building (see Pictures 10 and 11). Plants were noted growing in the junction between the exterior wall and the tarmac. Water can gather in the wall/tarmac seam. Freezing and thawing of gathered water can result in damage to the exterior wall, which can result in water penetration into the building.

Space In Exterior Wall/Tarmac Junction

Damaged Concrete In Foundation At Rear Of Building

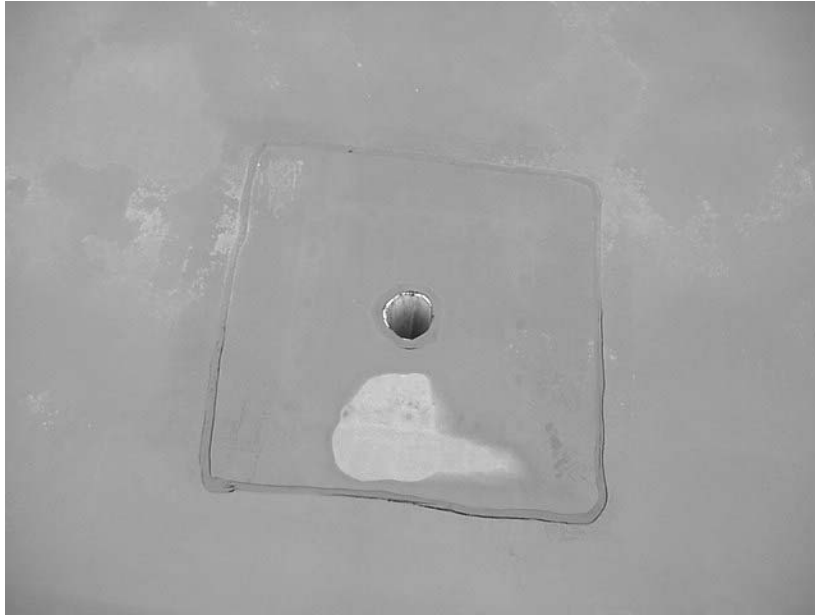
Picture 12

6. The design of the drainage for the roof makes it prone to overflowing during downpours. The TTH has a flat roof covered with a rubber membrane that is connected to a single ~3' diameter drain (see Picture 12). Under certain conditions, the drain may not be able to drain at a sufficient rate to prevent water overflow from the roof. Overflow can enhance water pooling along the south wall of the TTH.
7. Shrubbery exists in close proximity to the foundation walls (see Picture 13). The growth of roots against the exterior walls can bring moisture in contact with wall brick and eventually lead to cracks and/or fissures in the foundation below ground level. Over time, this process can undermine the integrity of the building envelope and provide a means of water entry into the building through capillary action through foundation concrete and masonry (Lstiburek, J. & Brennan, T.; 2001).

Roof Drain

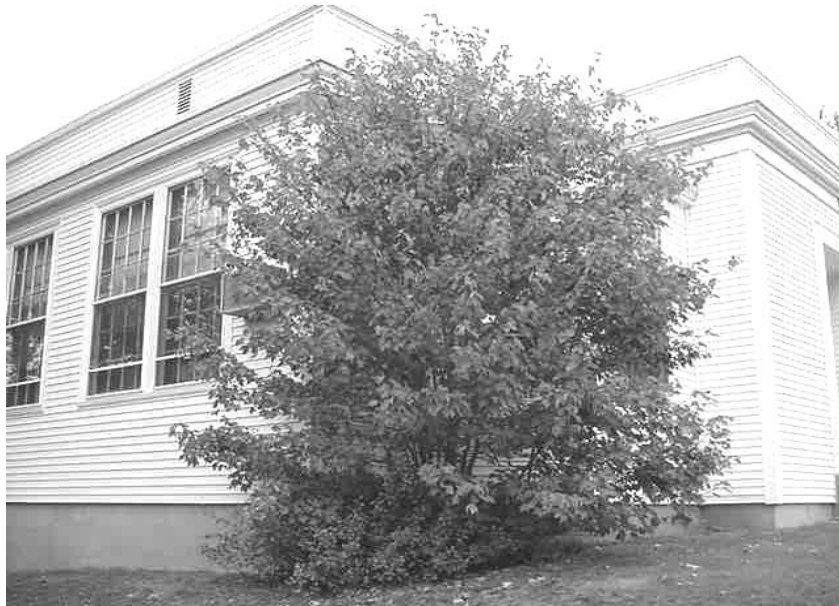
Picture 13

Shrubbery Adjacent To Foundation Wall

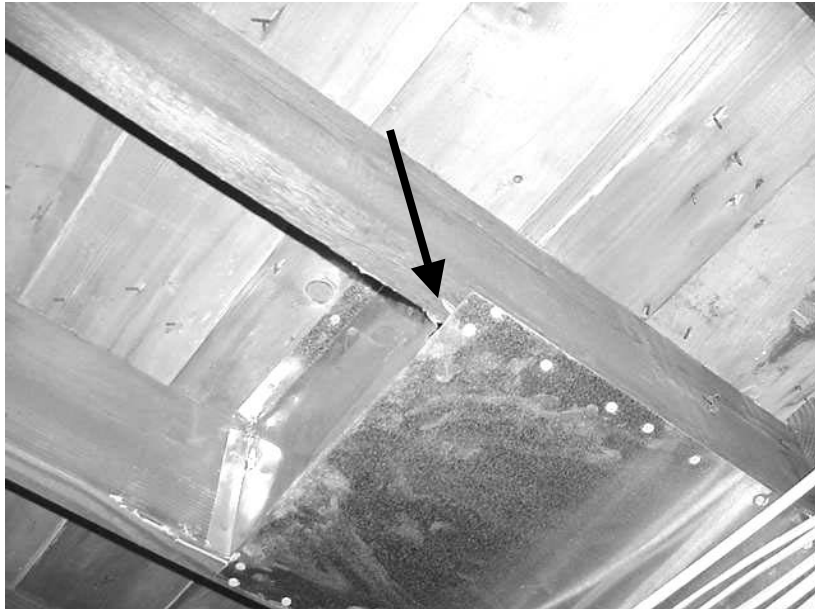
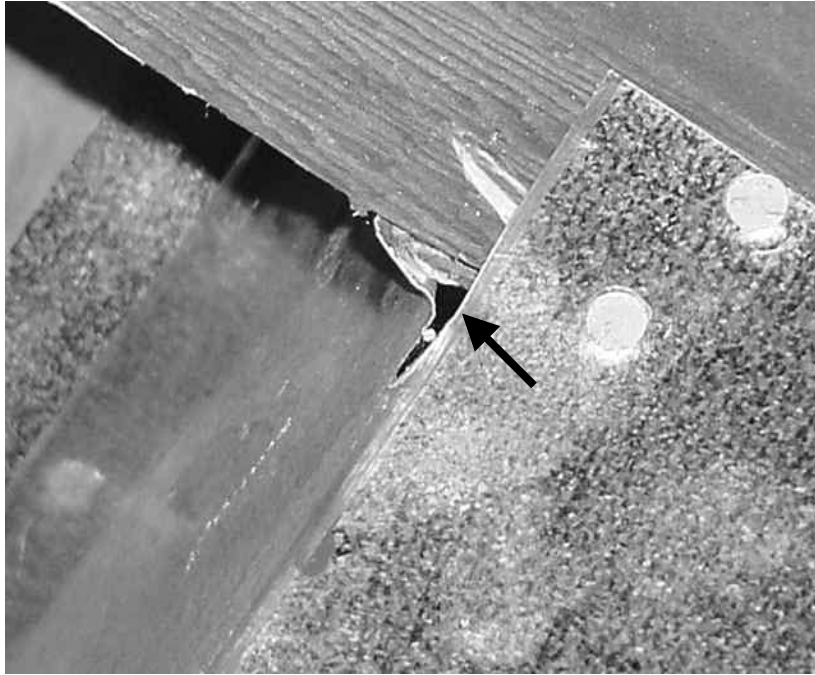
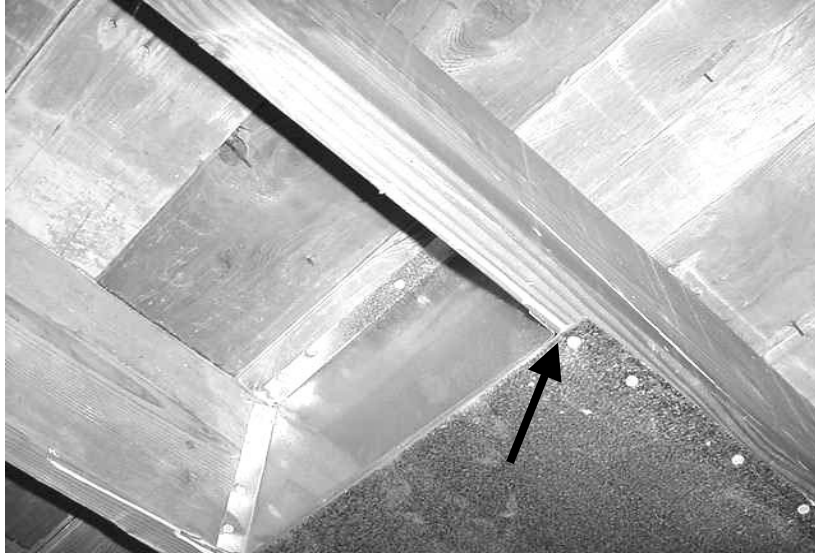
Each of these concepts has an influence on the movement of basement odors and/or related particulates up the stairwell. Of particular note is the condition of the ductwork of the return vents of the AHUs. Each return duct appeared to have a seam that was open to the basement (see Pictures 14 through 16). These open seams can draw air, odors, particles and other pollutants from the basement to be distributed into occupied areas. Without an active exhaust ventilation system, these pollutants can accumulate. In addition, penetrations for piping through the basement ceiling/office floors (see Picture 17) can serve as pathways for basement air to migrate into occupied spaces.

Return Duct Seam

Close-up Of Picture 14

1. Seal all spaces in return ducts.
2. Seal all spaces around utility pipes.
3. Keep the door to the basement closed. Install weather stripping and a door sweep on this door to create an airtight barrier.
4. Remove the carpet from the Planning Office in a manner consistent with US EPA mold remediation recommendations at:
http://www.epa.gov/iaq/molds/mold_remediation.html (US EPA, 2001).
5. Extend the length of the condensation drain a sufficient distance to allow for water to drain downhill away from the foundation.
6. Seal holes in the tarmac/exterior wall junction with an appropriate sealing compound. Repair damaged brick at rear of building.
7. Repair open seams in exterior siding.
8. To prevent moisture penetration into the basement, the following actions should be considered:

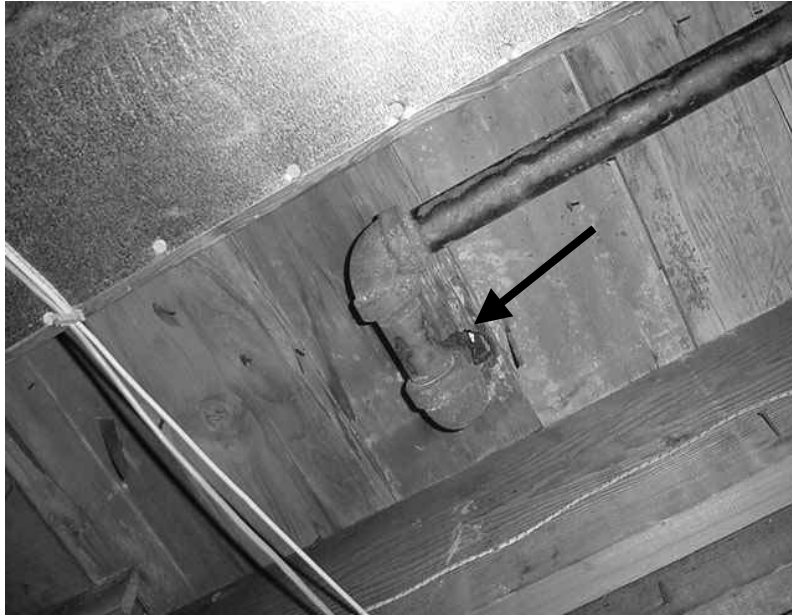
Picture 17

Pipe Penetration Through Floor, Note Light At Hole

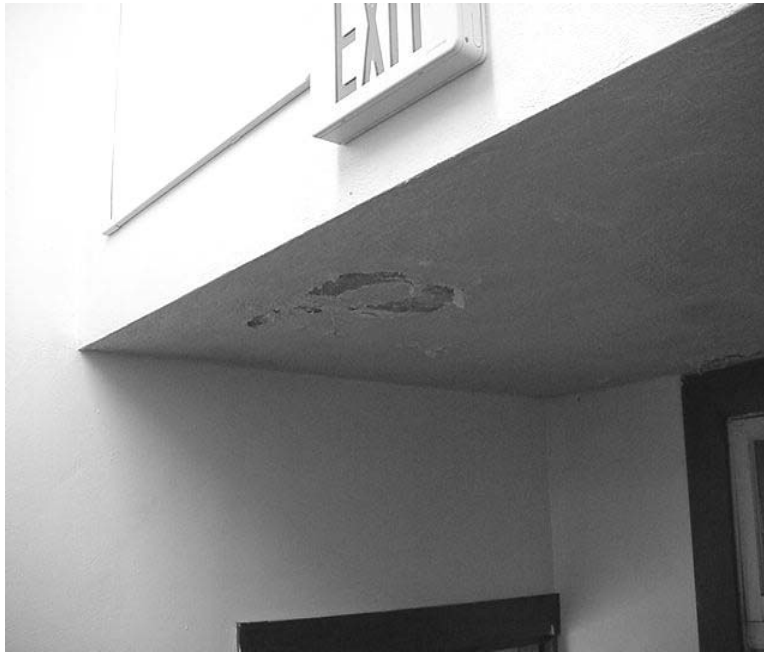
Picture 18

Several areas had signs of water damage (see Picture 18). Each of these areas appeared to correspond to junctions between roof structures that attach to the exterior siding of the building. As an example, open seams in the siding were noted above the lower roof of the southeast corner of the TTH (see Pictures 19 and 20). It appears that

Water Damaged Plaster

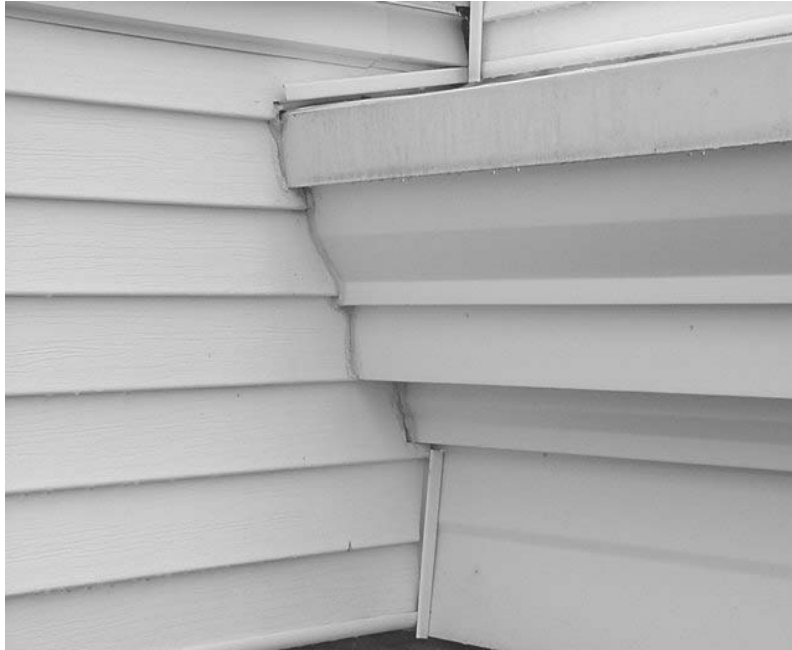
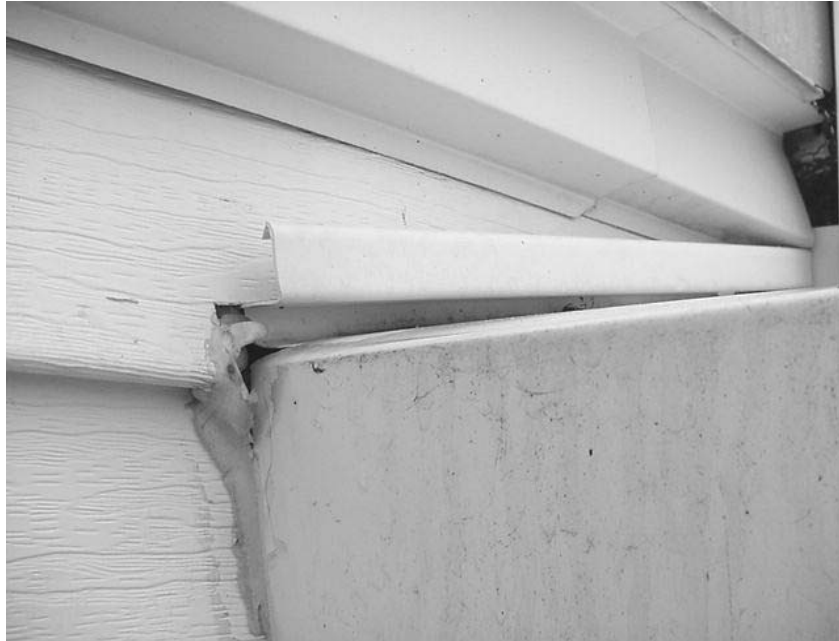
these seams were closed with a sealing compound that has eroded, resulting in a hole through which rainwater may pass. Each siding seam should be inspected twice a year to ensure continuity of the siding system to prevent water leaks.

Siding Above Roof Of Southeast Corner Of Building

Close-up Of Seam In Picture 19, Note Split Caulking

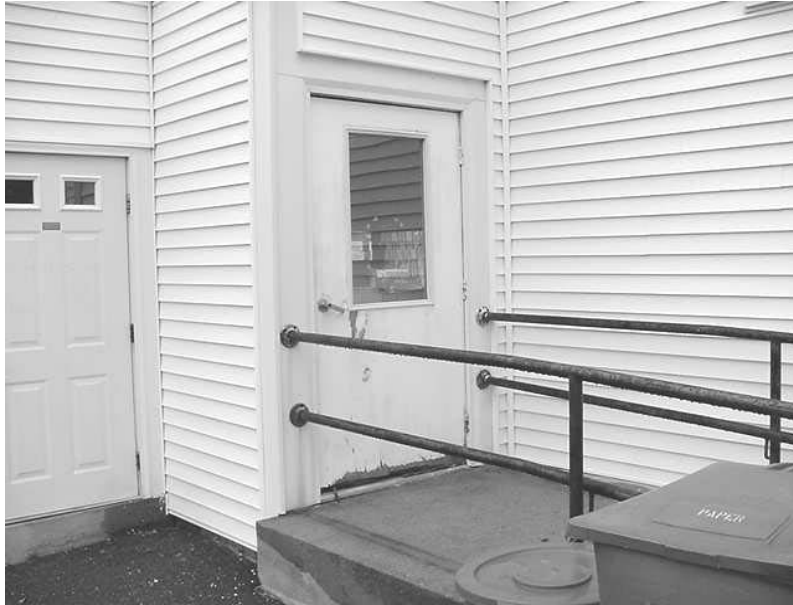
Picture 21

An exterior door at the southwest corner of the building had significant water damage (see Picture 21). The floor on the interior side of this door is carpeted. If water penetrates through the threshold of this door, the carpet may become wet.

Water Damaged Exterior Door

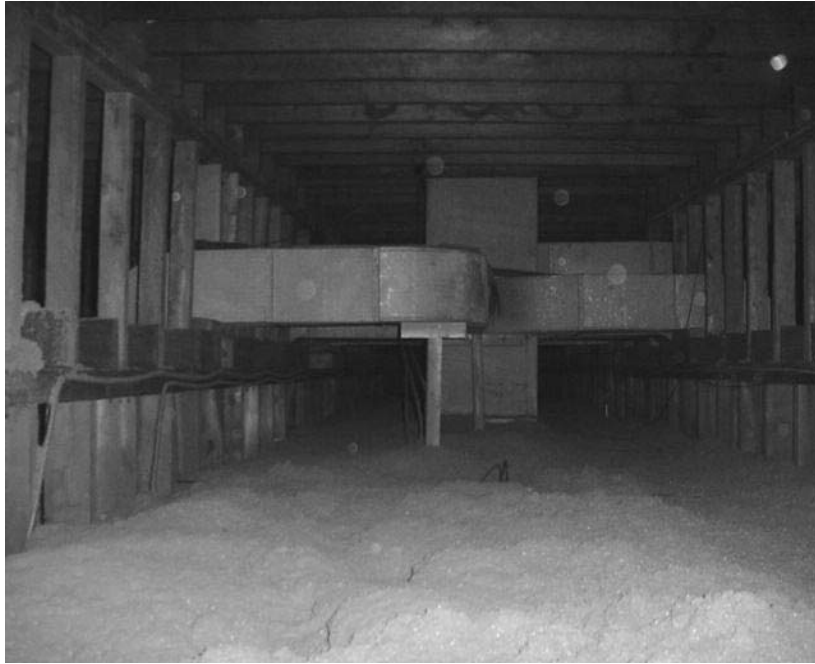
Picture 22

The attic is insulated with loose insulation (see Picture 22). The access way to the attic is a wood plug that is not airtight. Airflow around this plug may carry insulation fibers into the hallway. Insulation particles can be eye, skin and respiratory irritants and should be contained.

Loose Insulation In Ceiling Crawlspace

12. Consider installing local exhaust ventilation in the photocopier area.
13. Install weather-stripping around the edges of the attic crawlspace access way to render airtight.
